# Wits study investigates why Jagersfontein dam failed

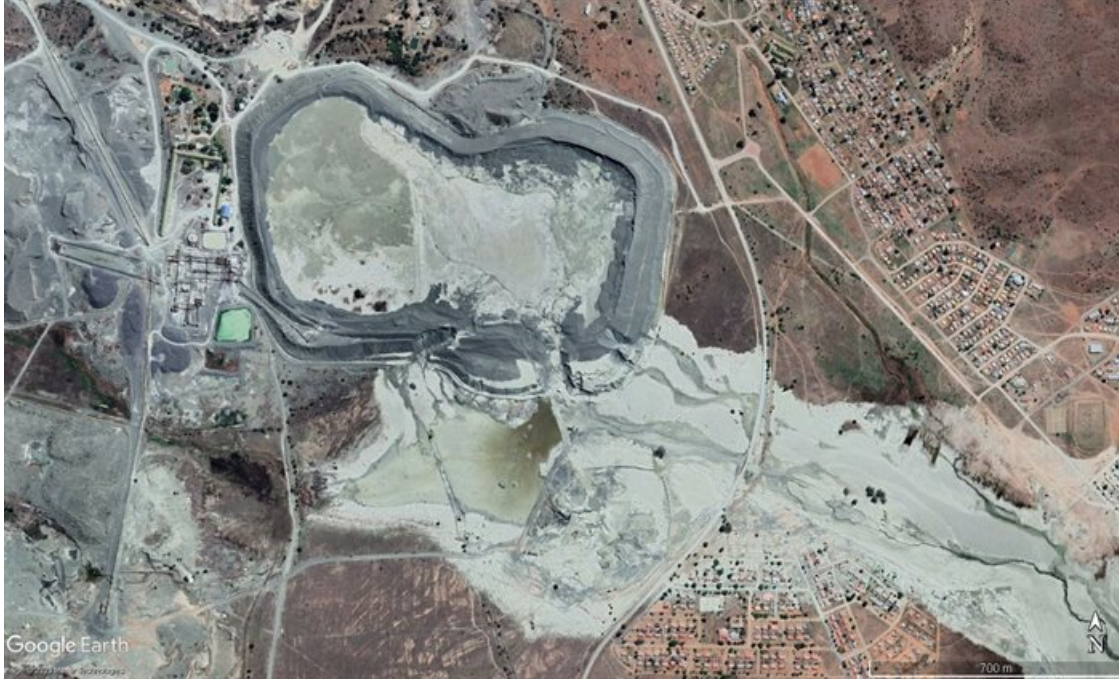
Post-failure satellite image of the Jagersfontein dam. Source: Google Earth Pro

The study found that the history of the Jagersfontein dam deviates from best engineering practice. The deviations include mine waste deposition from predominantly one side of the dam, erosion gullies on the dam wall, and significant amounts of ponded water at times positioned against the retaining structure.

Based on the analysed images, the study hypothesises that percolation of water through the dam, followed by external

erosion, ultimately triggered instability.
