Buildings left standing in Turkey offer design guidance for future earthquake-resilient construction

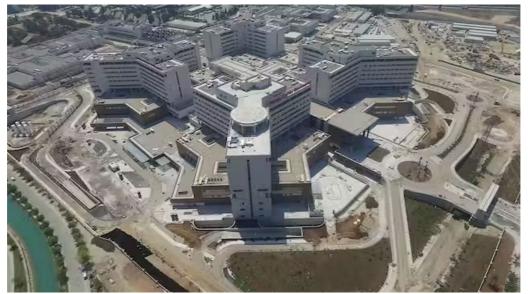
Turkey's Adana Hospital survived the February 2023 earthquakes with no damage because of its seismic isolation system. Earthquake Protection Systems, Inc., CC BY-ND

Adana City Hospital was built to record both ground shaking and the building's response. Thanks to its seismic isolation system, the building saw a 75% <u>reduction in shaking</u>, according to the company that designed the isolation system, compared with neighbouring structures. This system allowed the building to stay up and running after the earthquake.

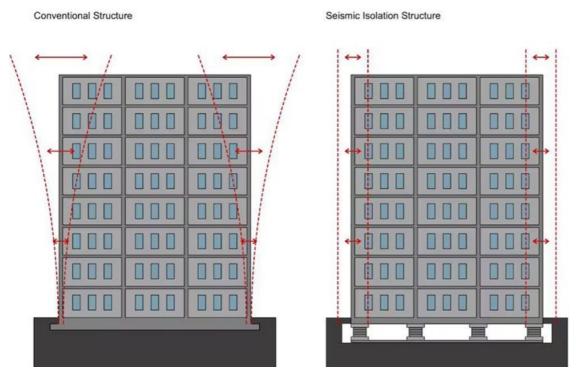
The left shows a building without seismic isolation, while the right image shows a building with a seismic isolation system which minimises how much damage the building sustains during an earthquake. The red lines denote how much motion the building could experience during an earthquake. Ozbulut Lab, CC BY-ND

<u>Seismic isolation systems</u> prevent seismic energy from entering buildings in the first place by using devices made from rubber or steel plates coated with a friction-generating material that slide over one another to minimise an earthquake's impact. These isolation devices are installed between the building's foundation and the building itself. Alternatively, seismic dampers, installed in each story of a building, absorb earthquake energy the way shock absorbers work in a car and convert it into heat energy to <u>minimise damage</u>.
